REPORT OF SUBSURFACE EXPLORATION
AND WELL INSTALLATION
PELHAM PHOSPHATE COMPANY
PELHAM, GEORGIA
LETGO JOB NO. CO-818

SKETCH of OUTSIDE WASTE PILE AREA
PELHAM PHOSPHATE COMPANY

Site Analysis
Stoller Chemical/Pelham Phosphates Company
Pelham, GA

**SHEETPILE/TOP CAP INSTALLATION
STOLLER CHEMICAL SITE
PELHAM, GEORGIA**

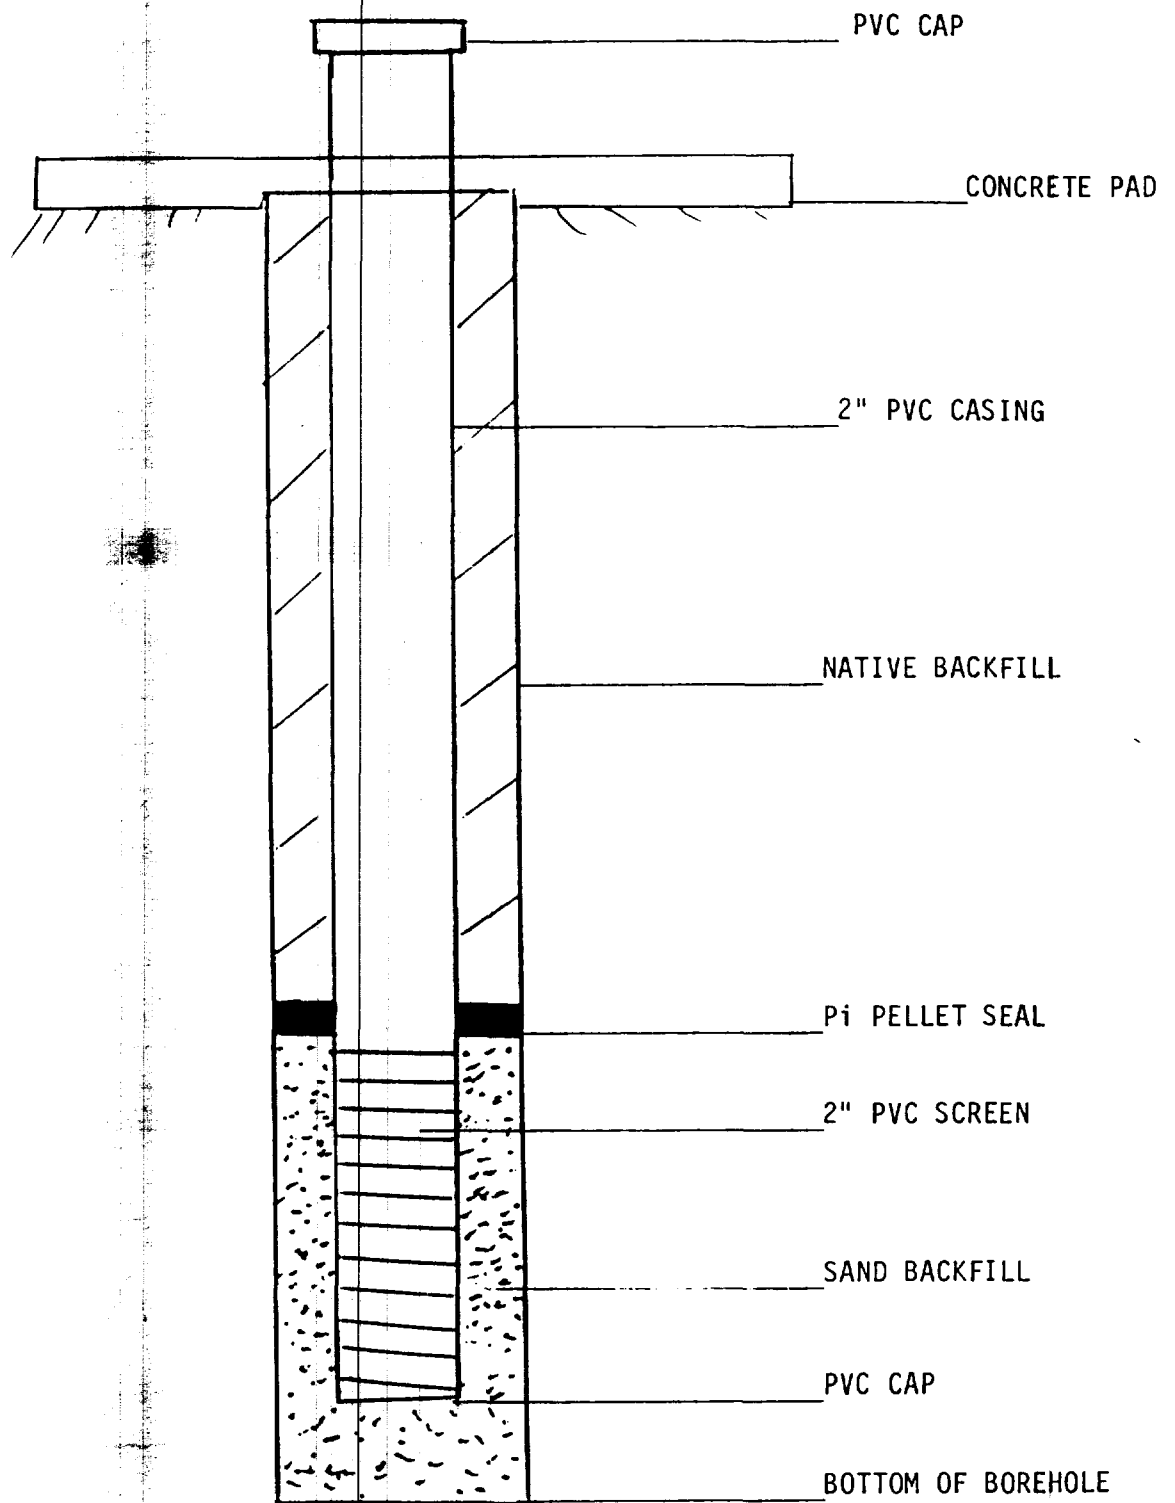
GENERALIZED CONSTRUCTION DIAGRAM

2" PVC threaded casing and
screen. Installed in 4"
borehole with sand pack
around screen. Topped by
a Pi pellet seal and native
blackfill. Well finished
with the pouring of a 2'x2'
concrete pad.
10' of screen-20' of casing.
2' of casing above groundleve

GROUND WATER MONITORING WELL

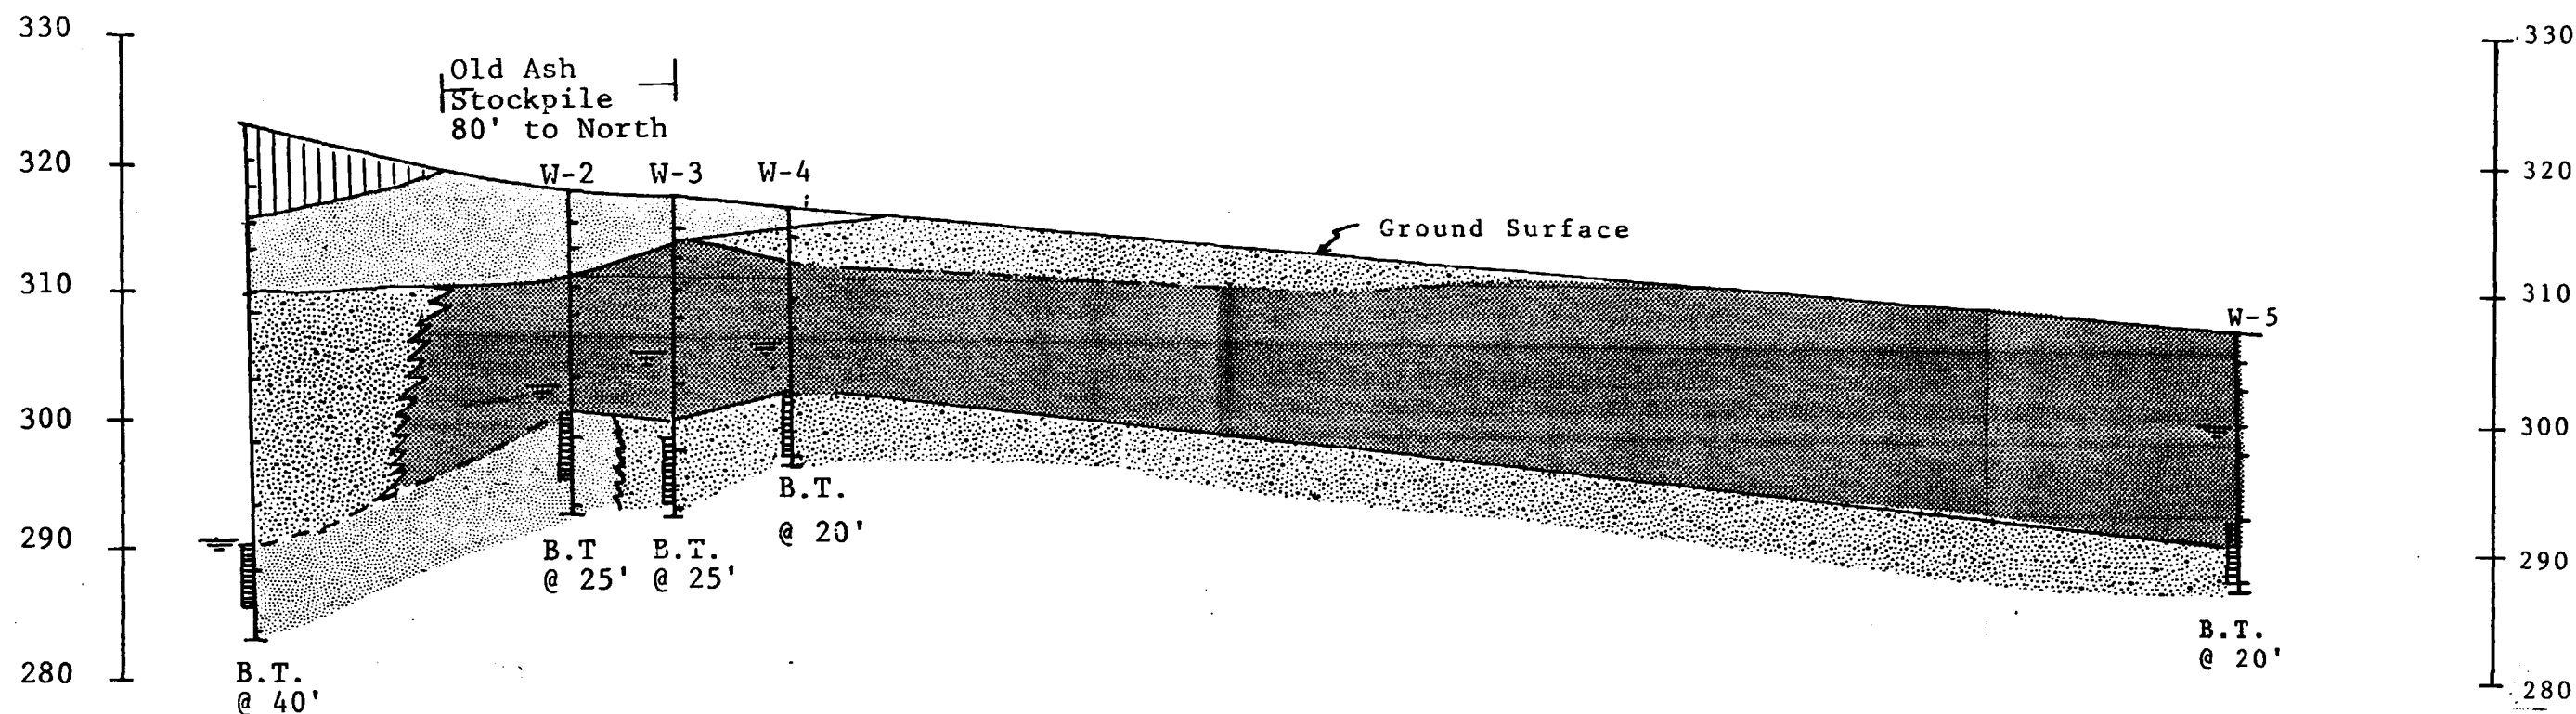
Generalized Cross Section
Pelham Phosphate Company
Pelham, Georgia

- Clayey Silt
- Silty Sand
- Clayey Silty Sand and Clayey Sand
- Silty Clay

The five soil test borings were drilled to depths of 20 to 40 feet. Standard penetration tests were conducted in general accordance with ASTM D-1586 (detailed procedures presented in the Appendix). Small disturbed (split spoon) samples were obtained during this test and were visually classified by a geologist. The subsurface conditions encountered at the boring locations are shown on the attached Well Records. These Well Records represent our interpretation of the subsurface conditions based on the field logs and visual examination of field samples. The lines designating the interface between various strata on the Well Records represent the approximate interface location. In addition, the transition between strata may be gradual.

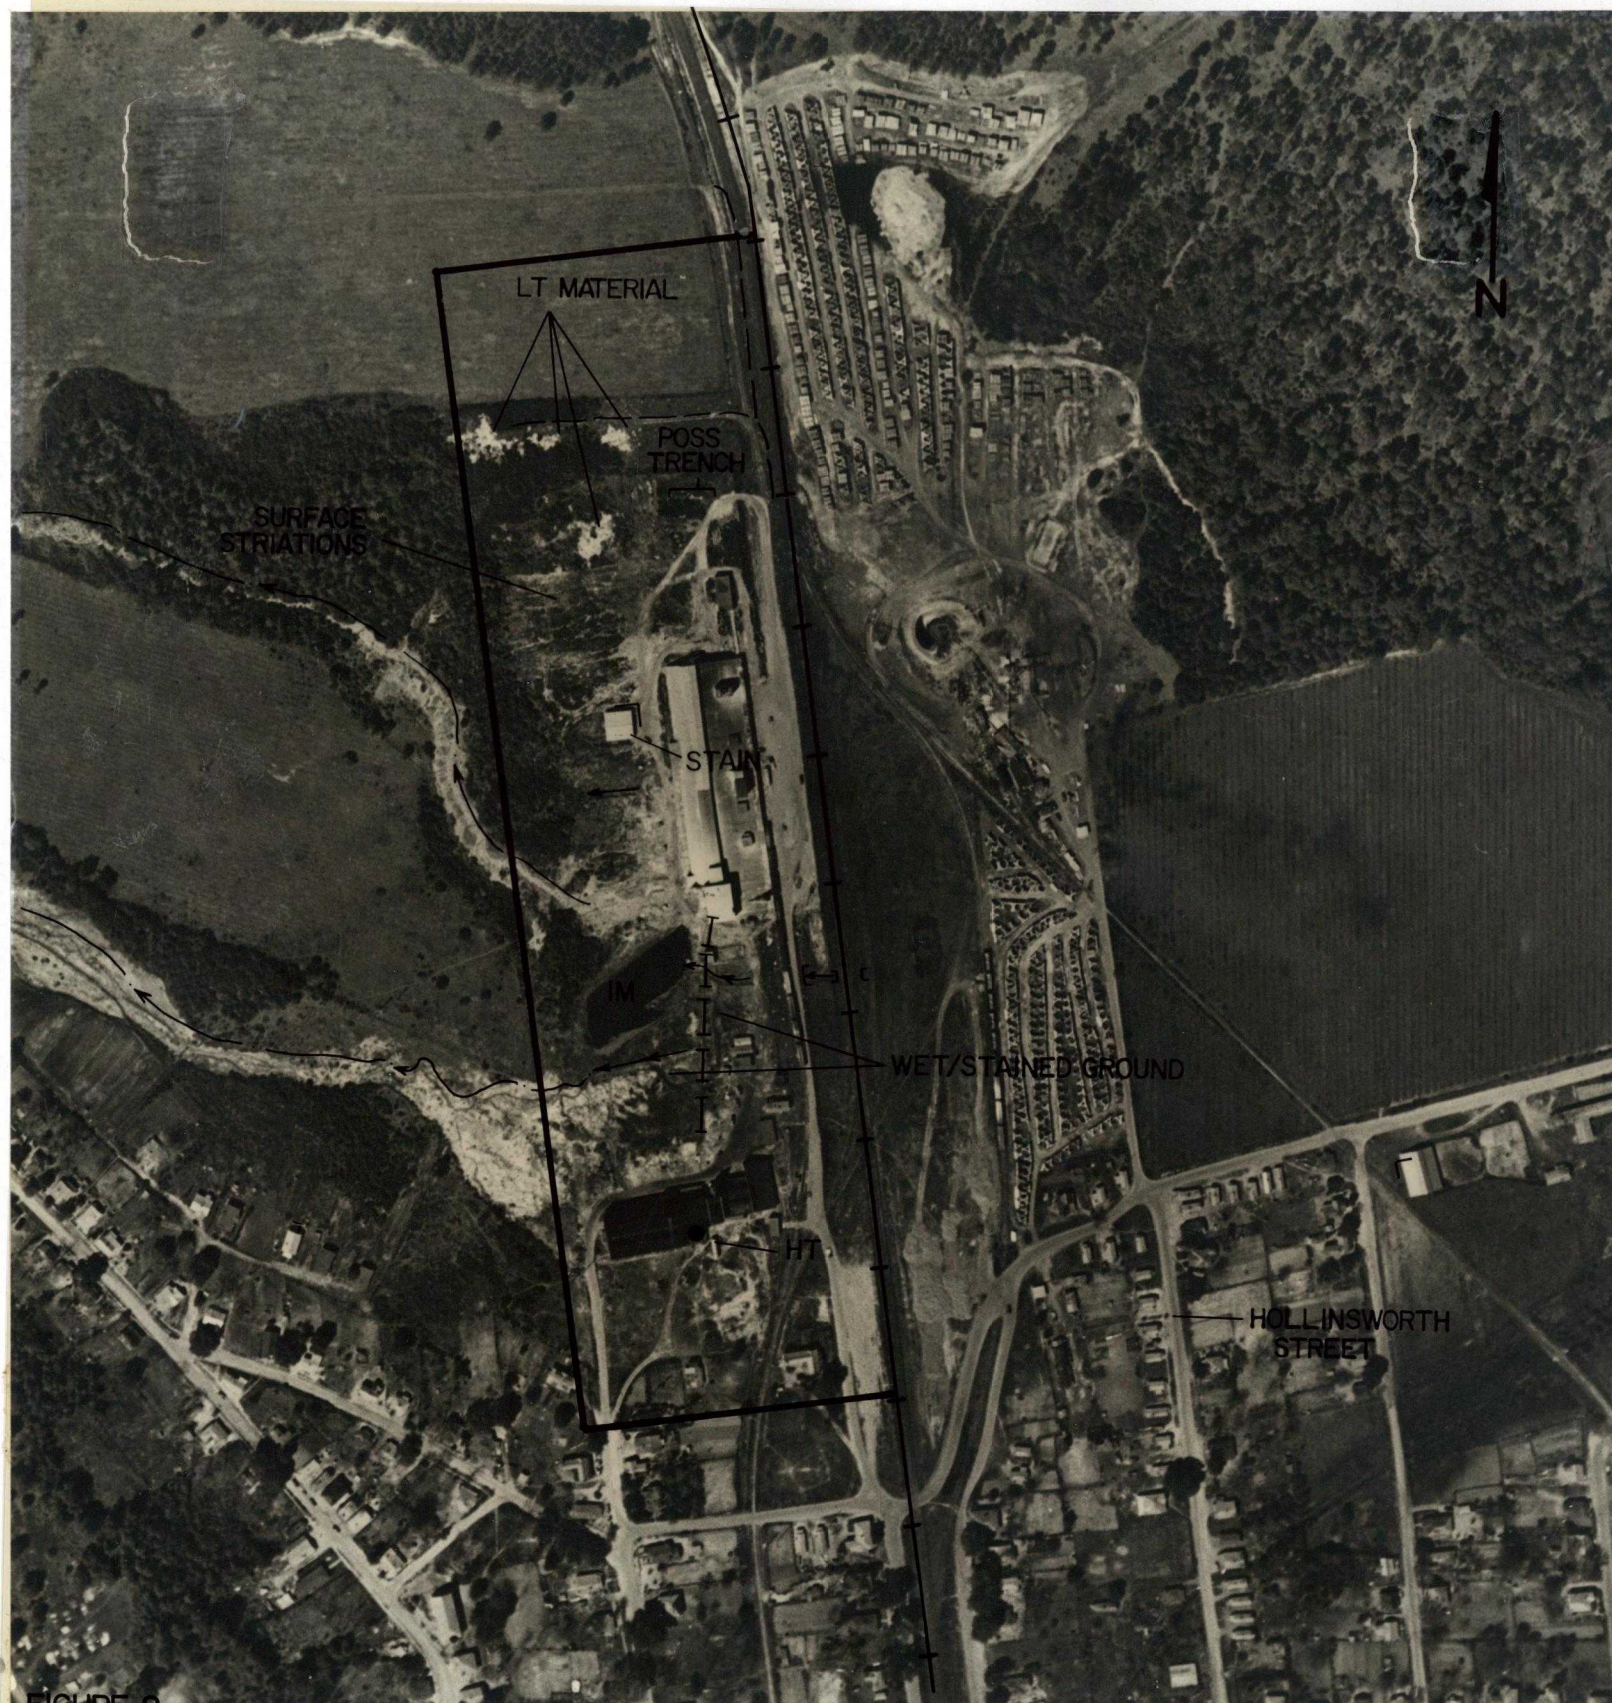
FIGURE 2
STOLLER CHEMICAL / PELHAM PHOSPHATES Co.

The site encompasses approximately 7 hectares (17 acres) along the west side of the railroad. There are two large buildings with a pipeline running between them. The south end of the pipeline either runs underground or terminates before reaching the southern building. An impoundment (IM) is situated west of the pipeline and receives runoff from a drainage ditch that originates just east of the railroad tracks. The entire area between the two large onsite buildings is wet and/or stained and disturbed (not annotated). This area is characterized by these same conditions throughout the analysis and will not be discussed further. Surface runoff from this vicinity flows westward, entering the impoundment and two unnamed streams.

A small building with a stain emanating from its south side, a possible trench, and a sparsely vegetated area which exhibits surface striations from past heavy equipment activity are visible in the northern half of the site. Additionally, several locations of light-toned (LT) material deposits are noted. An onsite access road leads to the northern grouping of material deposits. An offshoot of this access road extends into the field north of the site; however, at this time there is no evidence of environmentally significant activity related to the site in this area.

APRIL 2, 1952

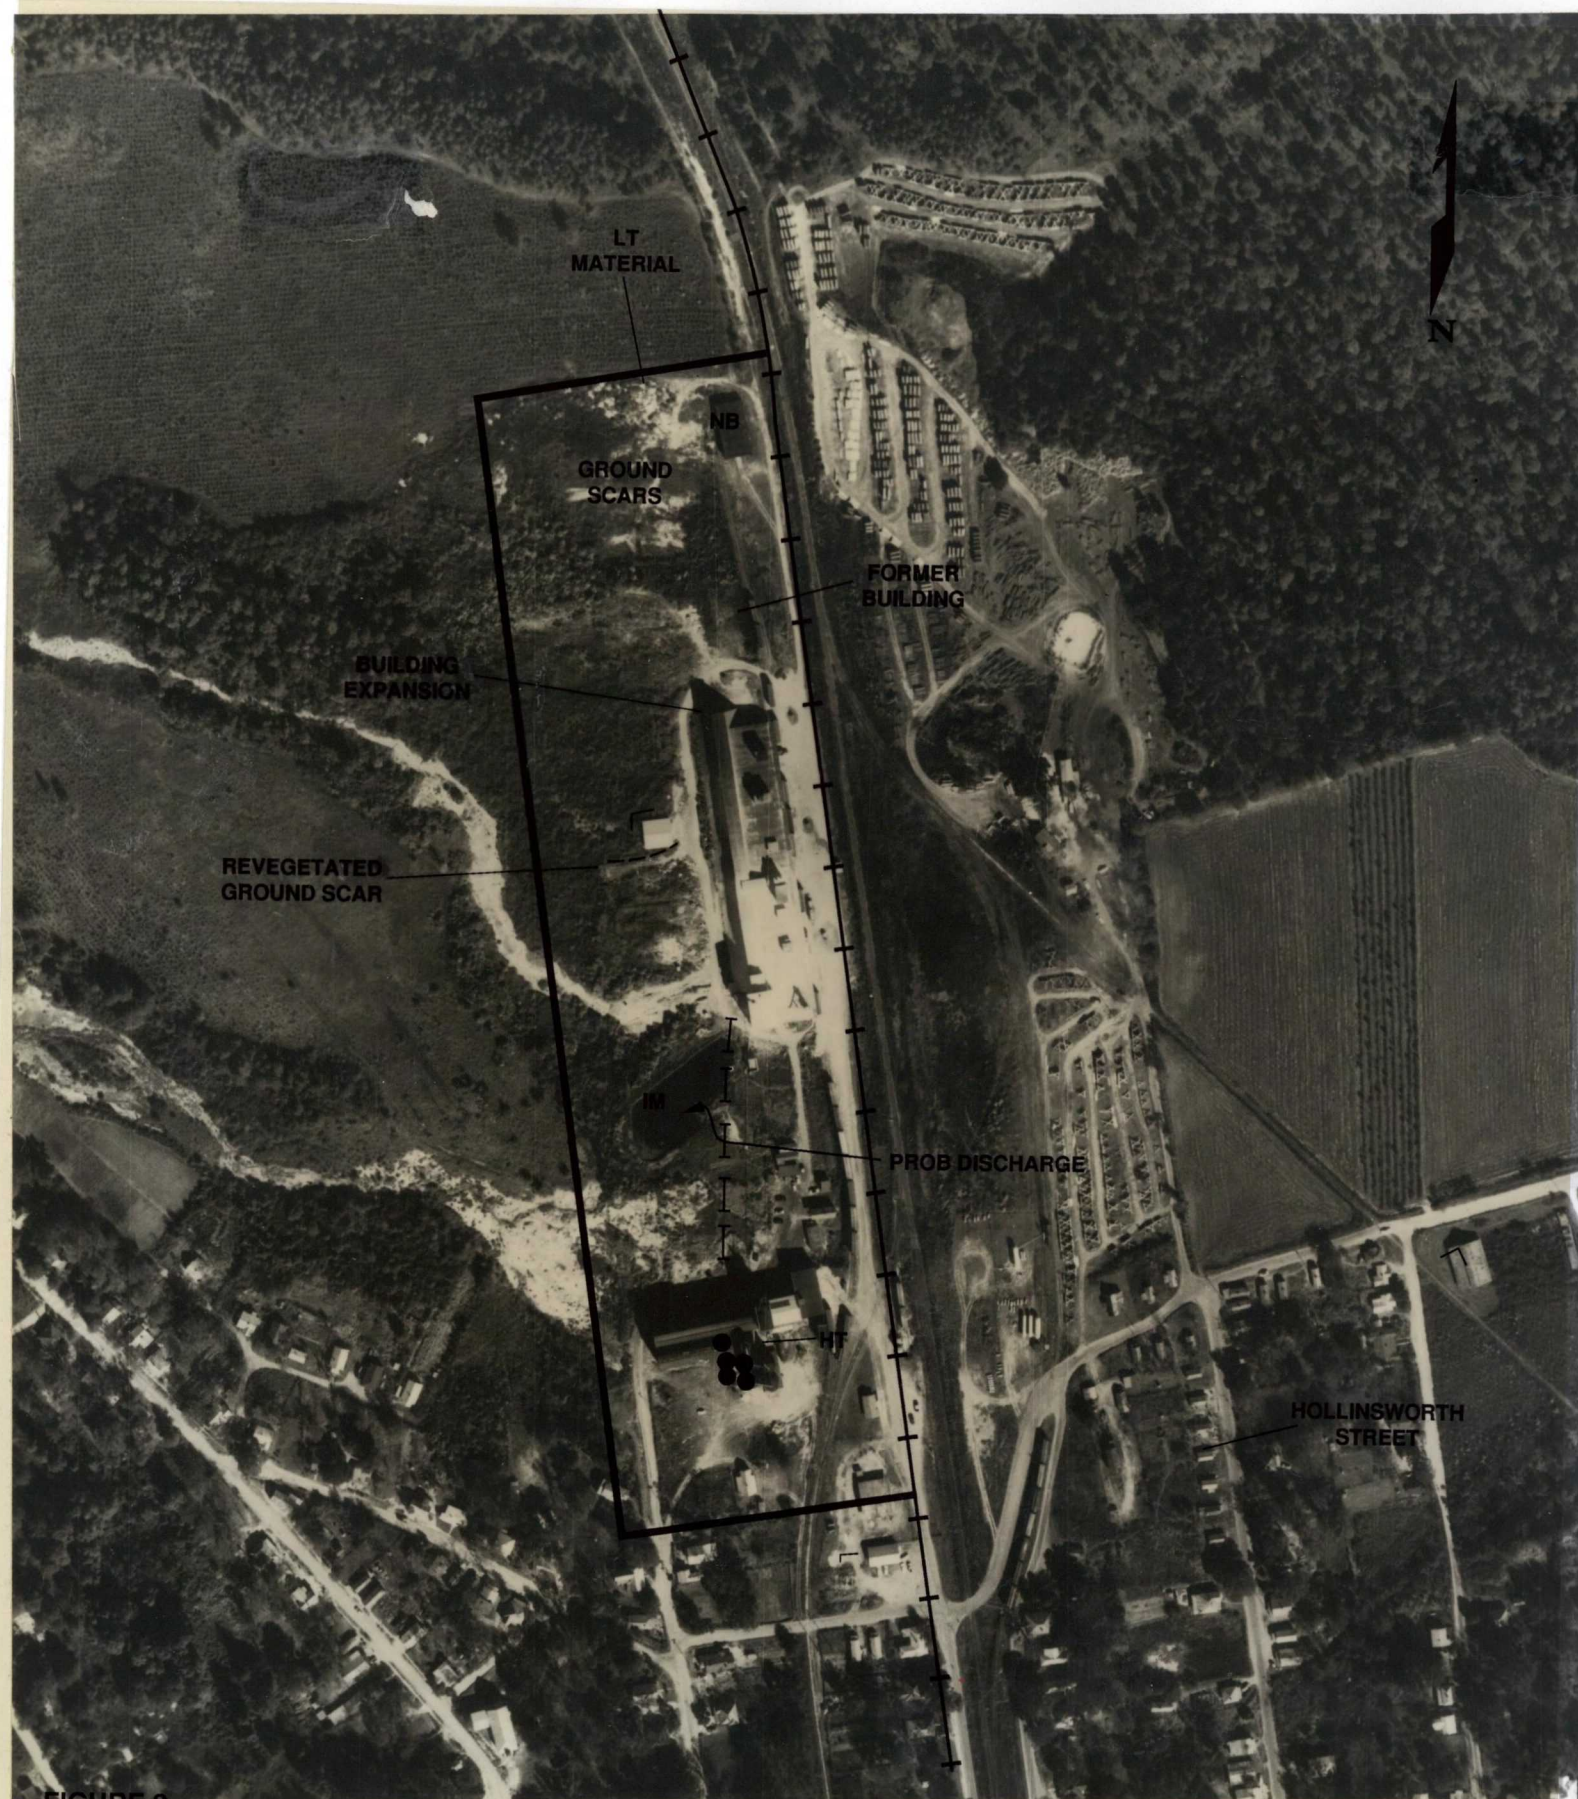
FIGURE 3
STOLLER CHEMICAL / PELHAM PHOSPHATES CO.

Production activity at the site appears to have increased as the northern building has expanded slightly and new tanks have been added at the southern building (note: pipelines are seen running between tanks, and between tanks and buildings throughout the remainder of the analysis; no attempt was made to document these pipelines and connections). A small building has been removed and another one added in the northern portion of the site.

An area devoid of vegetation extends from the pipeline to the impoundment suggesting a probable discharge. A revegetated ground scar is noted west of the northern large building. Vehicle access to this area is observed, suggesting a past disposal location. In the northern portion of the site, deposits of light-toned material and ground scars from equipment operation are noted. Much of the remaining northern portion of the site has revegetated, obscuring the surface striations visible in 1952.

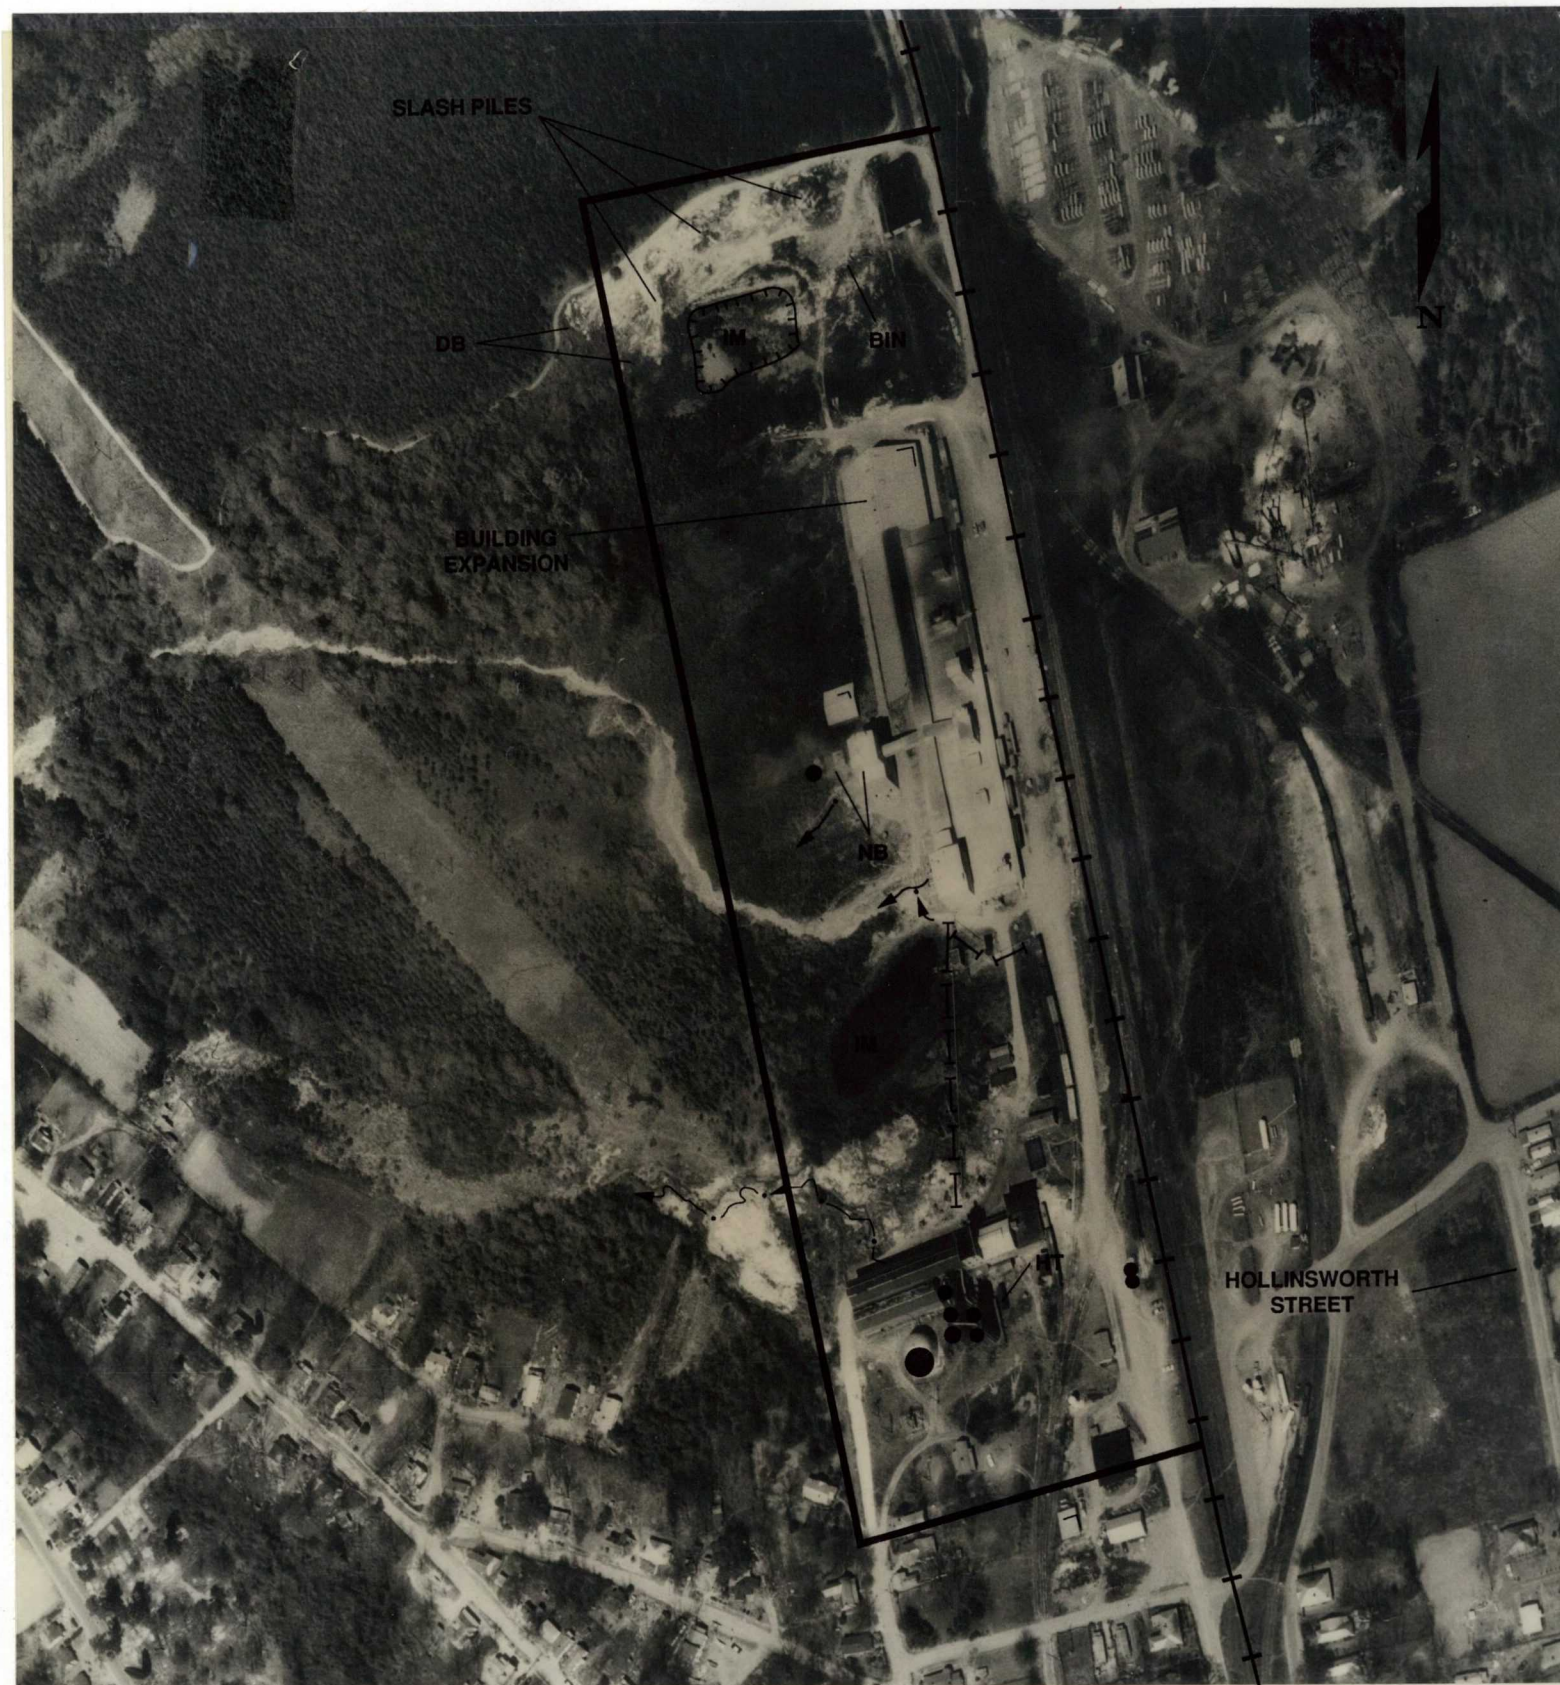
FIGURE 4
STOLLER CHEMICAL / PELHAM PHOSPHATES CO.

Building expansion, new buildings (NB), and new tanks are noted onsite this year. Another section of the pipeline is visible this year. Due to the poor resolution of photography spanning the period 1979 through 1988 it cannot be determined if this section remains in place; however, it is again visible in the 1993 photography.

A new impoundment has been excavated in the northern portion of the site. The impoundment contains liquid in its west end and is not lined. A bin and several other objects are visible east of the impoundment. Slash piles from recent clearing activity and scattered debris (DB) are visible north and west of the impoundment, respectively.

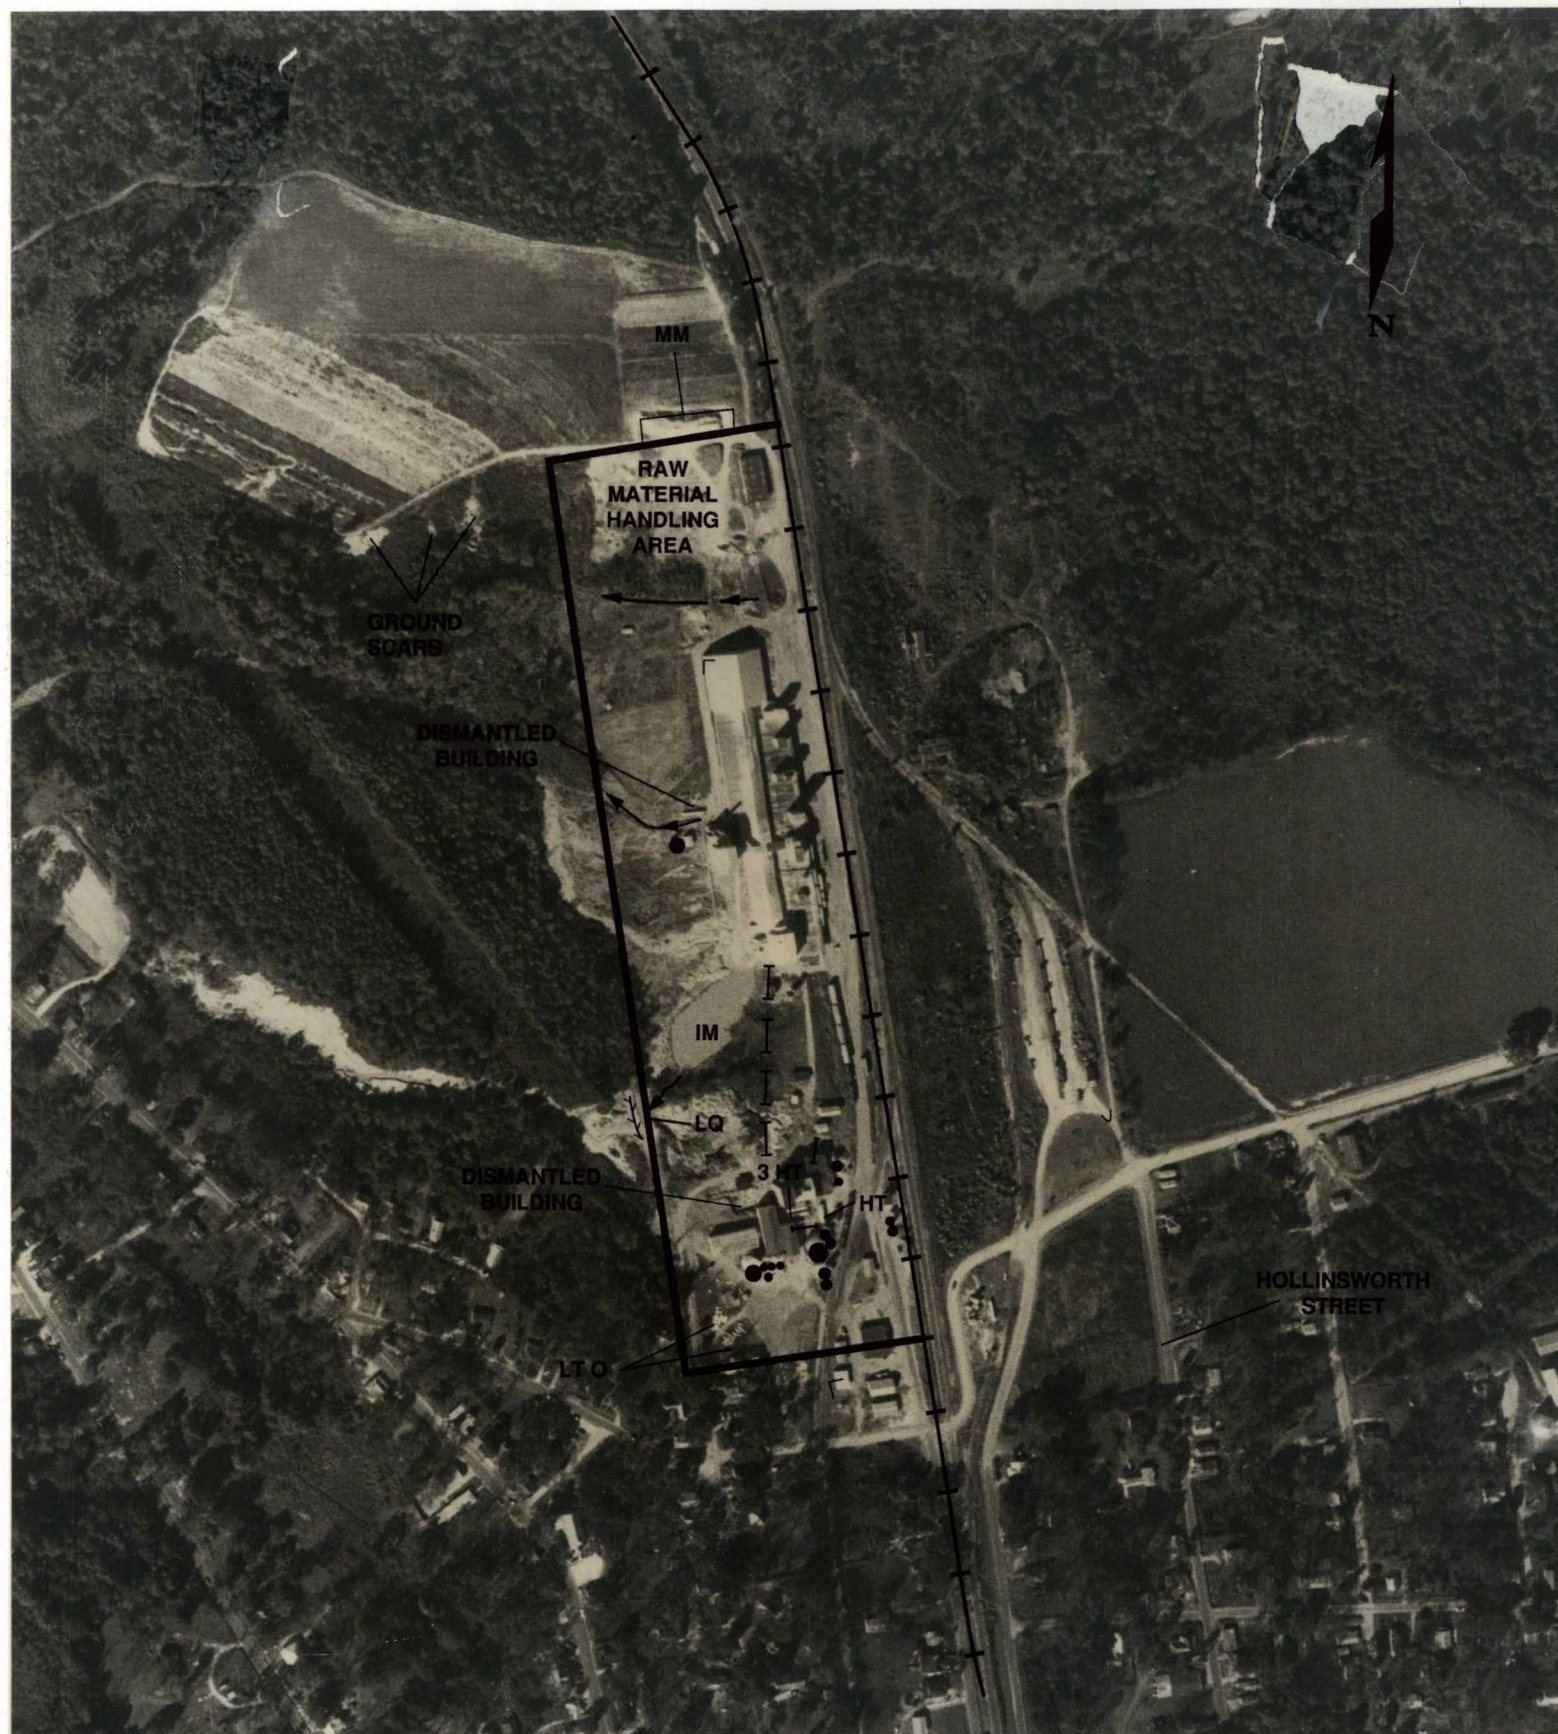
FIGURE 5
STOLLER CHEMICAL / PELHAM PHOSPHATES CO.

A new earthen berm has been added downslope of the impoundment to contain liquid (LQ) running from the impoundment.

A new raw material handling area is present in the northern portion of the site where the unlined impoundment was observed in 1968. This area is characterized by piles of material and equipment (none annotated) associated with this operation. A large mound of raw material (MM) is present offsite on the north side of the handling area. An access road (not annotated) leads west from this area to several ground scars. It cannot be determined if these are the result of deposition of material, ground disturbance, or partial remnants of the debris observed near this location in 1968.

NOVEMBER 4, 1979

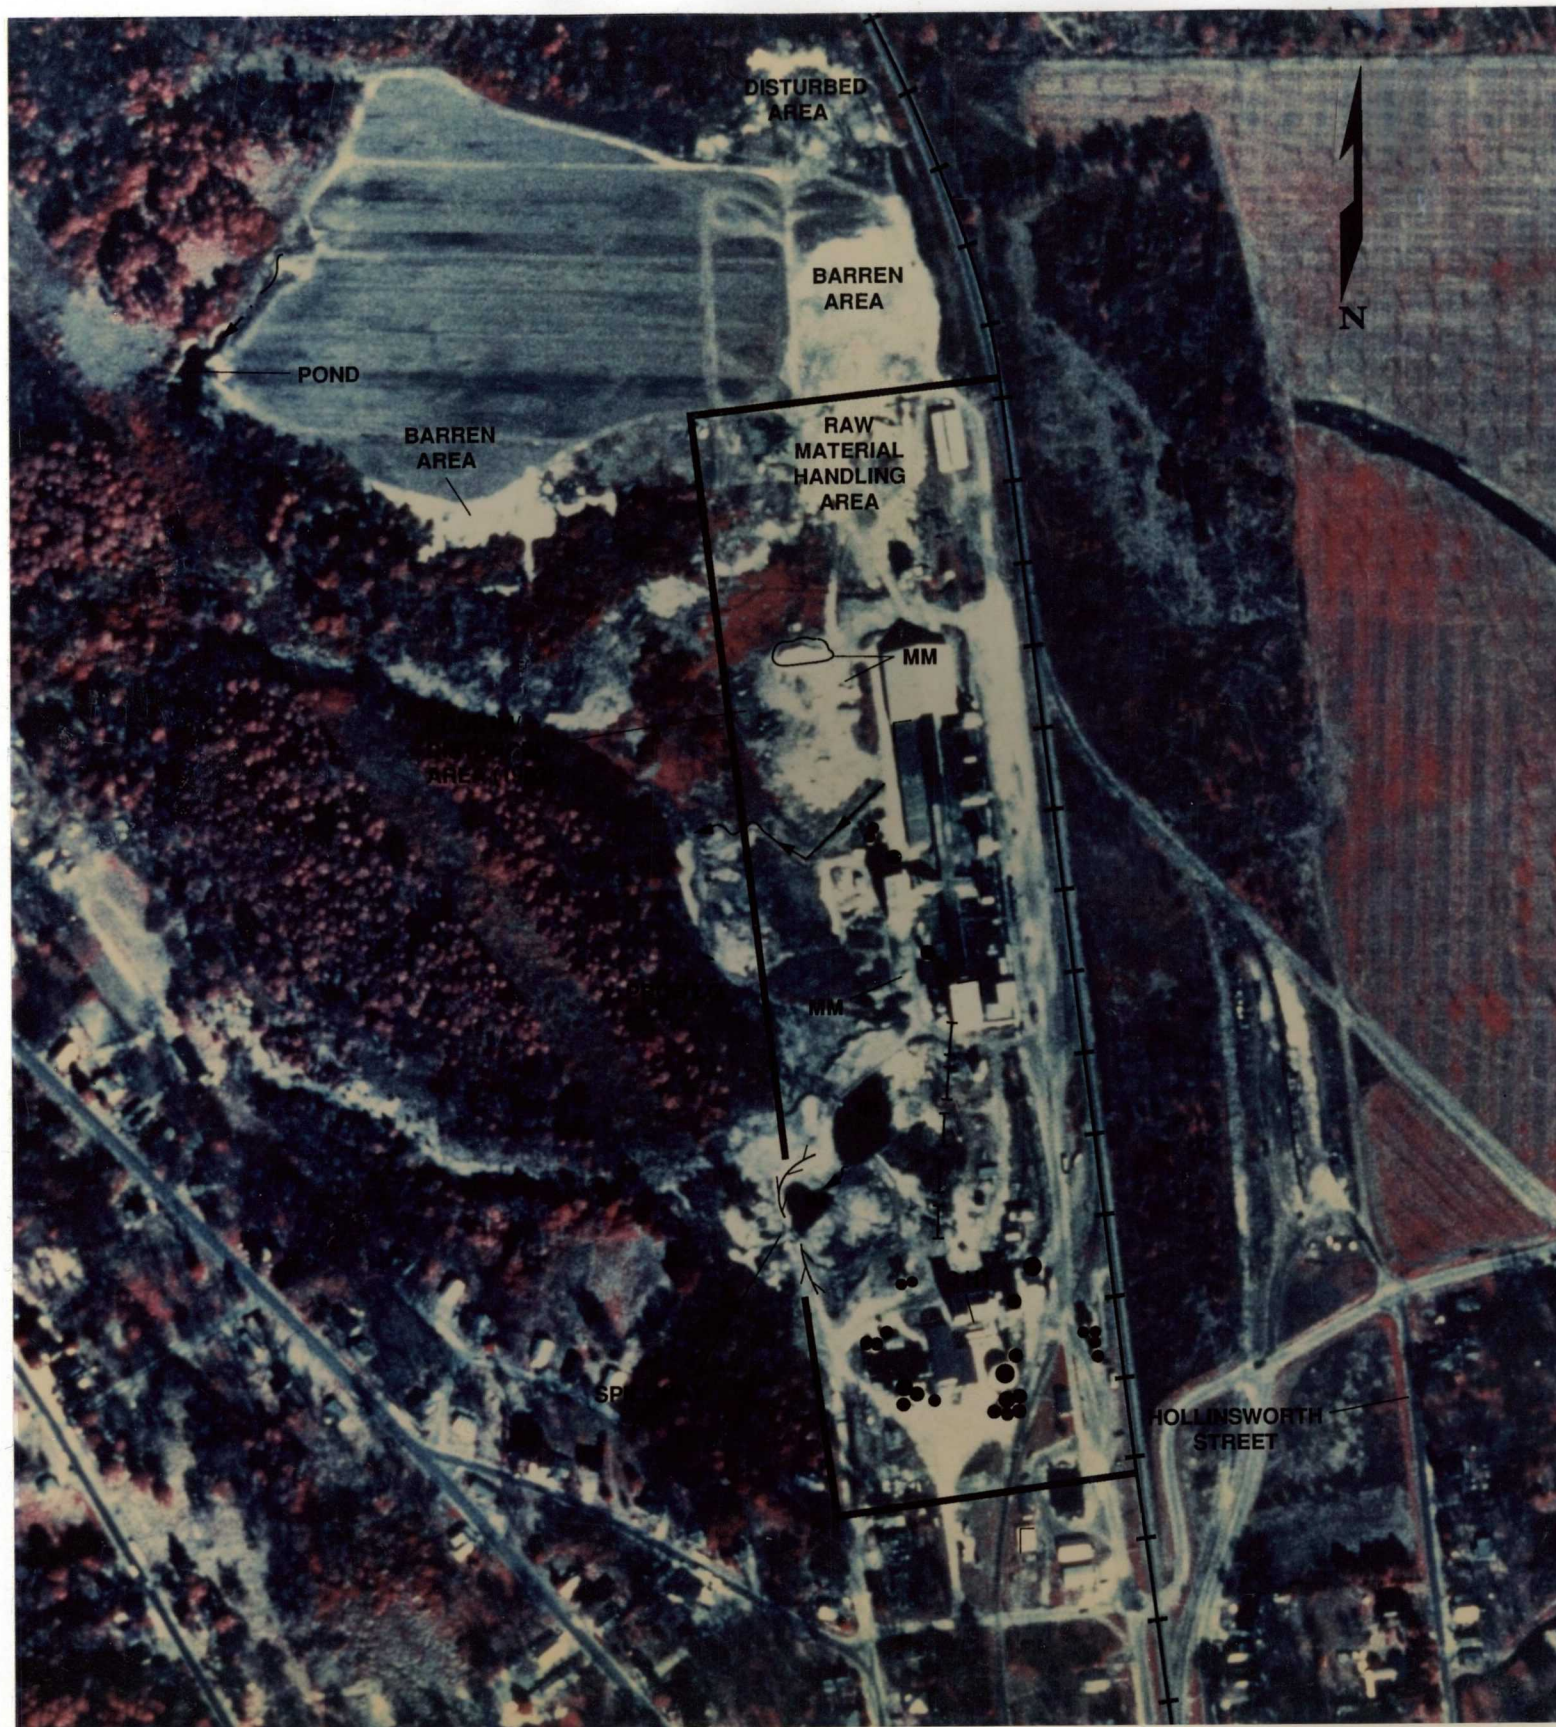
FIGURE 6
STOLLER CHEMICAL / PELHAM PHOSPHATES CO.

The raw material handling area remains active. A considerable amount of degradation of the vegetative cover has occurred from the raw materials handling area to the northern unnamed stream west of the site (area not annotated). This was also noted in 1983 and may be the result of sedimentation from the handling area and/or vegetation stress resulting from percolation of possible contaminants, which may have been present in the unlined impoundment seen in 1968. Additional mounds of raw material are visible west of the northern large building onsite. In 1983 this area was vegetated. An overgrown rectangular possible impoundment or building foundation is visible at the west site boundary. In 1983 an access road led to this location, which at that time was disturbed.

Two barren areas and a disturbed area are noted offsite. The barren area west of the site is situated where ground scars were observed in 1979. Each of these offsite areas appear to be associated with onsite activities.

JANUARY 26, 1988

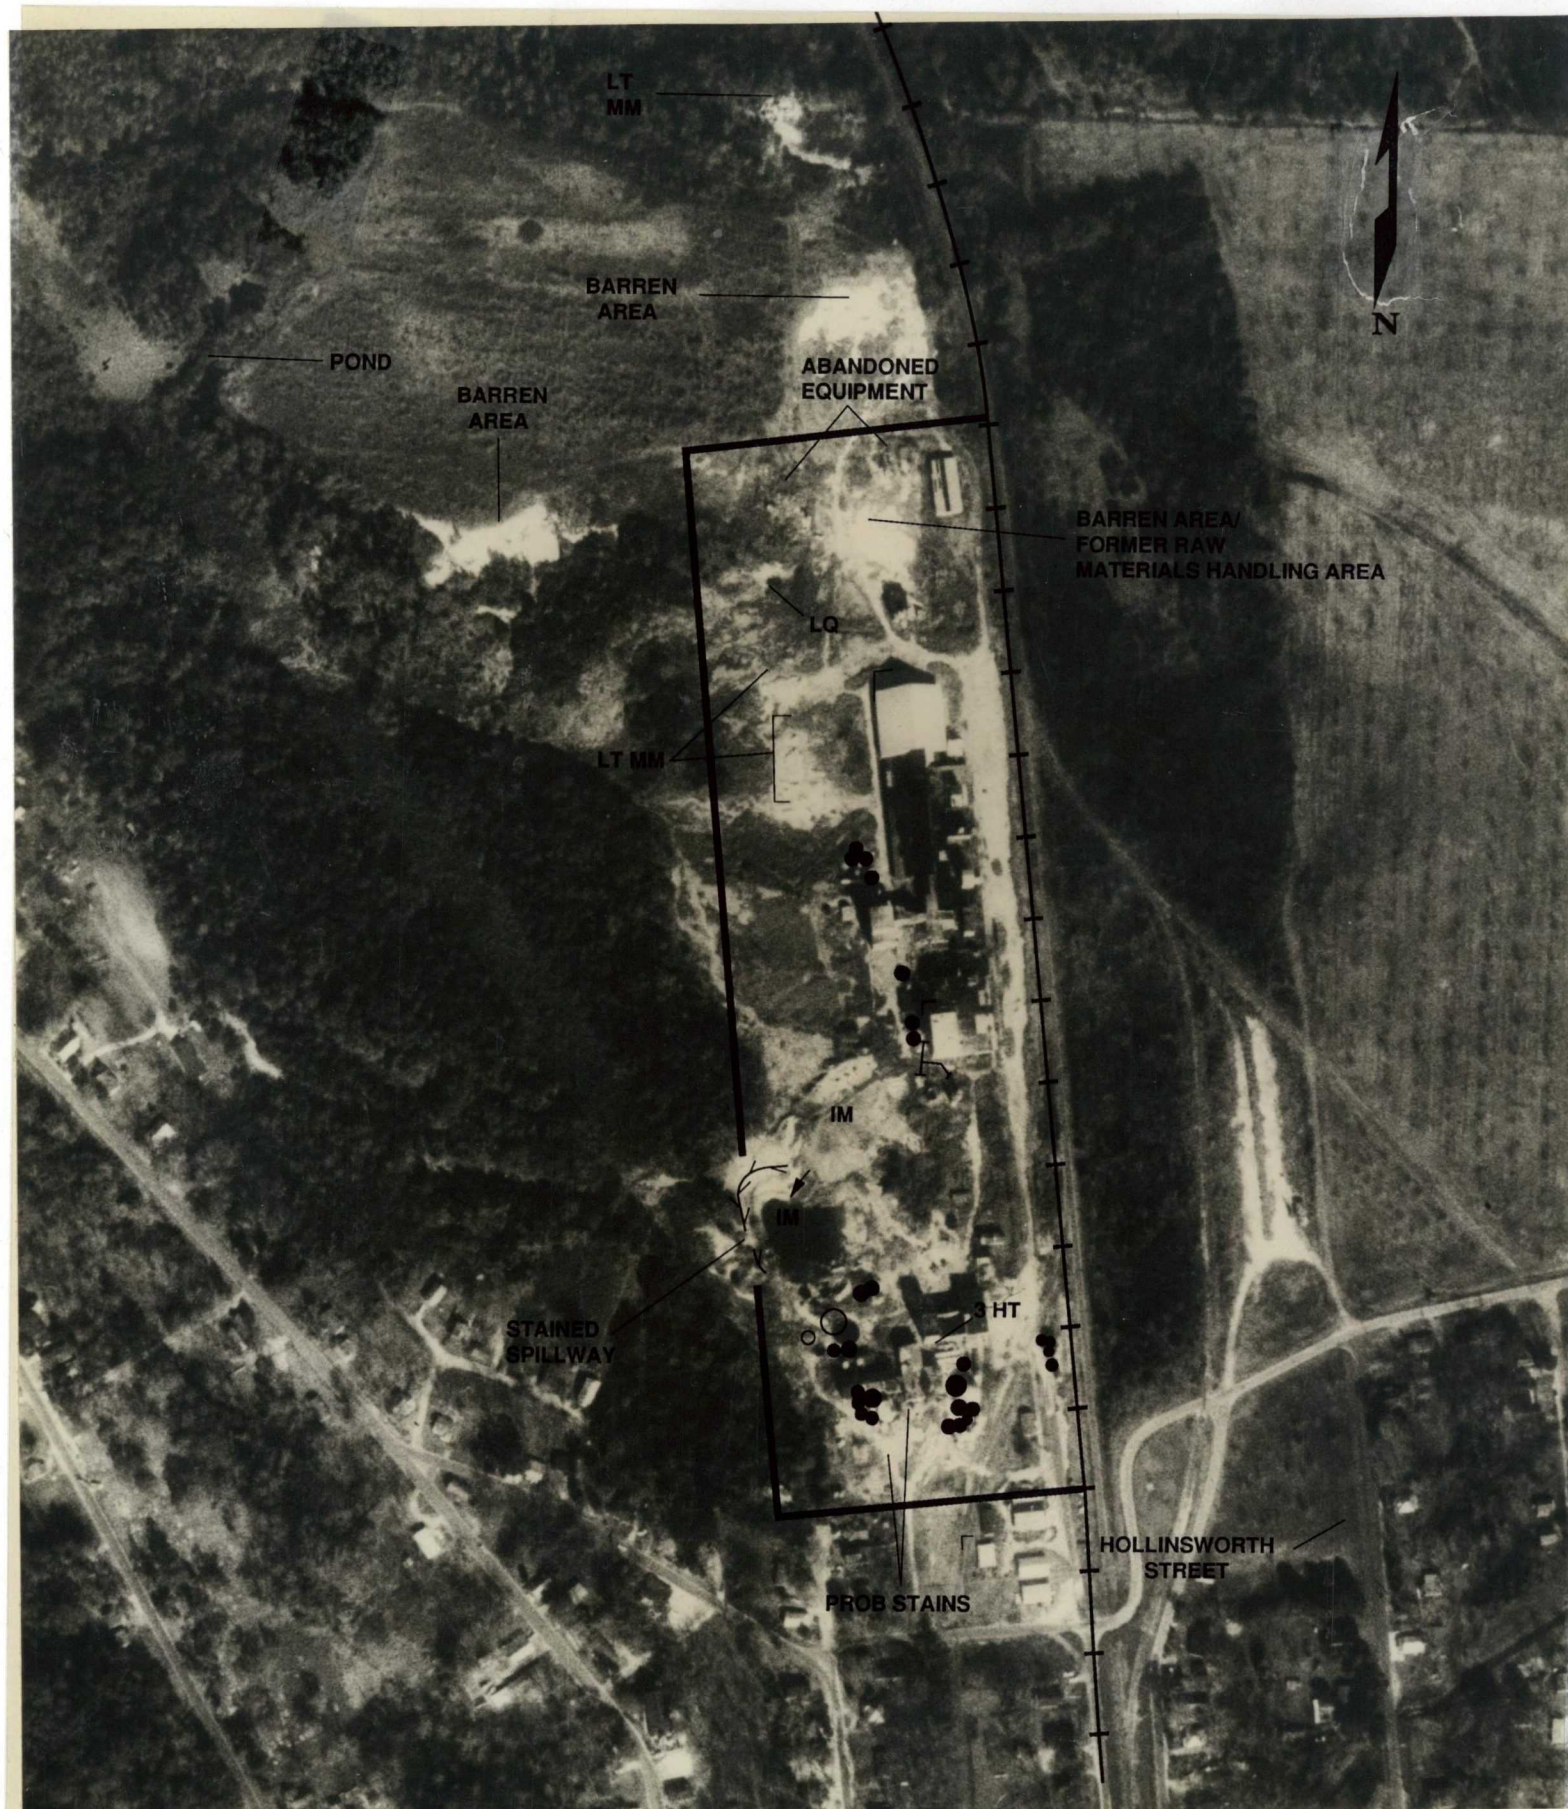
FIGURE 7
STOLLER CHEMICAL / PELHAM PHOSPHATES CO.

There is little change at the two impoundments in the southern portion of the site. No liquid is being discharged from the spillway of the lower impoundment; however, staining (not annotated) of the spillway is evident.

The raw materials handling area is no longer active, as the equipment is situated in a vegetated area and appears to have been abandoned. Much of the area is barren and several small piles of material (not annotated) remain in place. Liquid is noted southwest of the barren area, along the possible sedimentation and/or stressed vegetation pathway (not annotated) which extends to the unnamed stream.

Piles of light-toned material are visible onsite and in the formerly disturbed area north of the site. No significant change is noted at the two offsite barren areas.

JANUARY 23, 1993
